Monumental Issues

White Monument at Oconee Hill Cemetery Repaired

Another Tough Repair

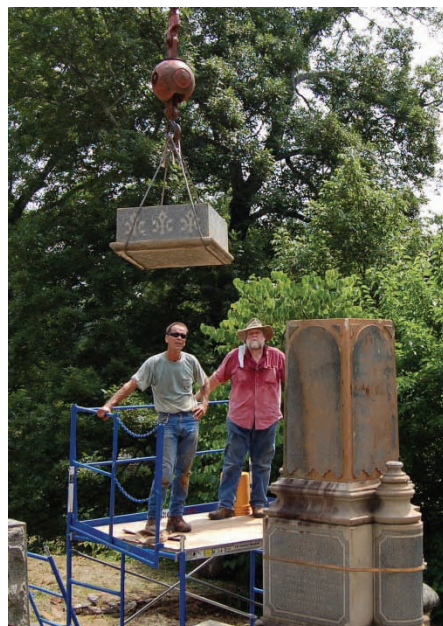
Resetting was also assisted by the availability of a photograph showing the monument shortly after it had been set. Identified by Friends Historian Charlotte Marshall, this photograph provides a rare glimpse of how things used to be done, including a wooden scaffold.

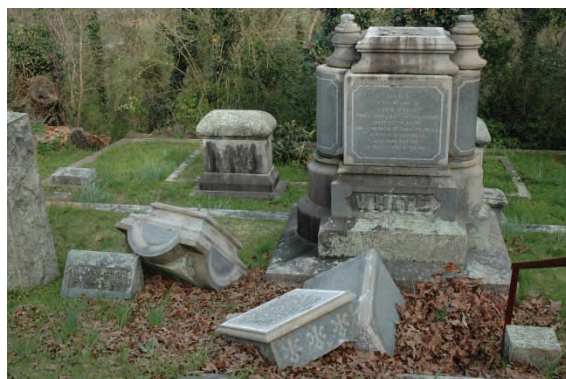
Before Treatment

In 1827, John White emigrated from Ireland to Athens, Georgia, and built the first cotton processing and clothes-manufacturing mill south of the Potomac River. The mill just below Athens was located in an area called Whitehall, now part of the University of Georgia campus. White died in 1888 and soon thereafter a 17 foot tall granite pedestal tomb was erected in his memory. That monument stood for nearly 120 years before it was toppled by a large tree during one of Athens storms.

The Friends of Oconee Hill Cemetery recently contracted with Chicora Foundation to reset the five downed monument sections and two broken urns. The largest portion on the ground weighed over 2,200 pounds, but all required special skill and very careful resetting. Using a local crane company and rigger, Chicora conservators were able to reset the monument in just over a day.

Monument rigging requires special skill, as well special pads and techniques to ensure that the stone is not further damaged. Using bits of canvas fire hose, rubber conveyor belt sections, and special nylon endless slings,

it was possible to reset the sections, while ensuring the safety of not only the monument, but also everyone involved in the work.

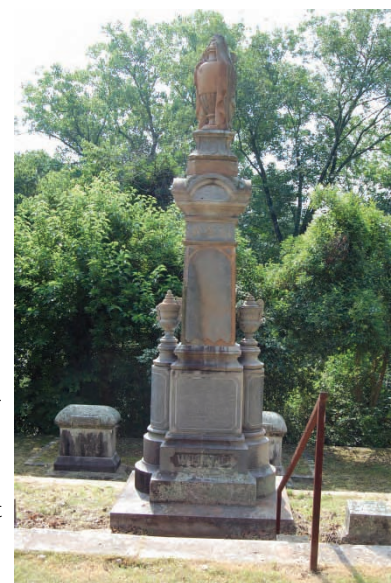
After Resetting

The monument, which includes both polished and dull finished faces with ornate carving, is topped by a draped urn, a common mourning symbol.

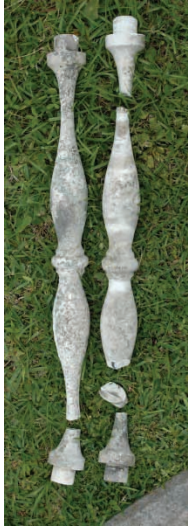
During Treatment — the hourglass spindles in the process of being pieced back together

They were repairing and resetting a badly damaged winged orb and hourglass atop the Robert Williamson monument. Damaged by a lightning strike about a year ago, the Friends organization raised funds to ensure its repair.

The repair began with over 30

fragments of the hourglass base and two spindles that had to be individually drilled and pinned.

Once most of the fragments were together they had to be added to the portion of the hourglass still remaining atop the column — and that required precision drilling.
